NASA TM X-52972

**SHOCK, VIBRATION, AND ACCELERATION-LOAD TESTS
OF A SNAP-8 MOTOR-DRIVEN LUBRICANT-COOLANT PUMP**

by A. J. Stromquist
Lewis Research Center
Cleveland, Ohio

C. L. Foss
Aerojet General Corp.
Azusa, California
March, 1971

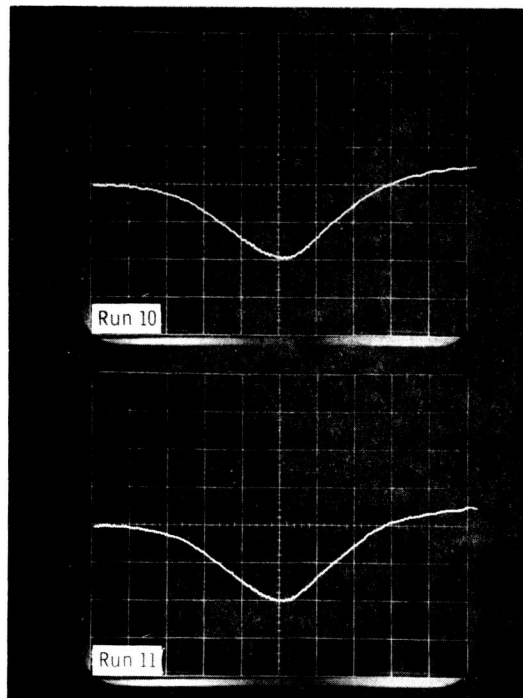
(a) Control accelerometer; Y axis.

Table I summarizes the shock testing, showing the programed machine inputs in each axis and the responses of the accelerometers mounted on the pump, also for all three axes. In general, the response accelerometers showed little amplification with the maximum being 25 percent in the +X axis. Also, the two mutually perpendicular axes showed no more than 2 to 3 G's with a 20-G input. A sample of the data, which was taken photographically from an oscilloscope, is shown in figure 7. The nonreturn of the trace to the abscissa merely means that vibrations resulting from the shock had not fully damped when the picture was taken.

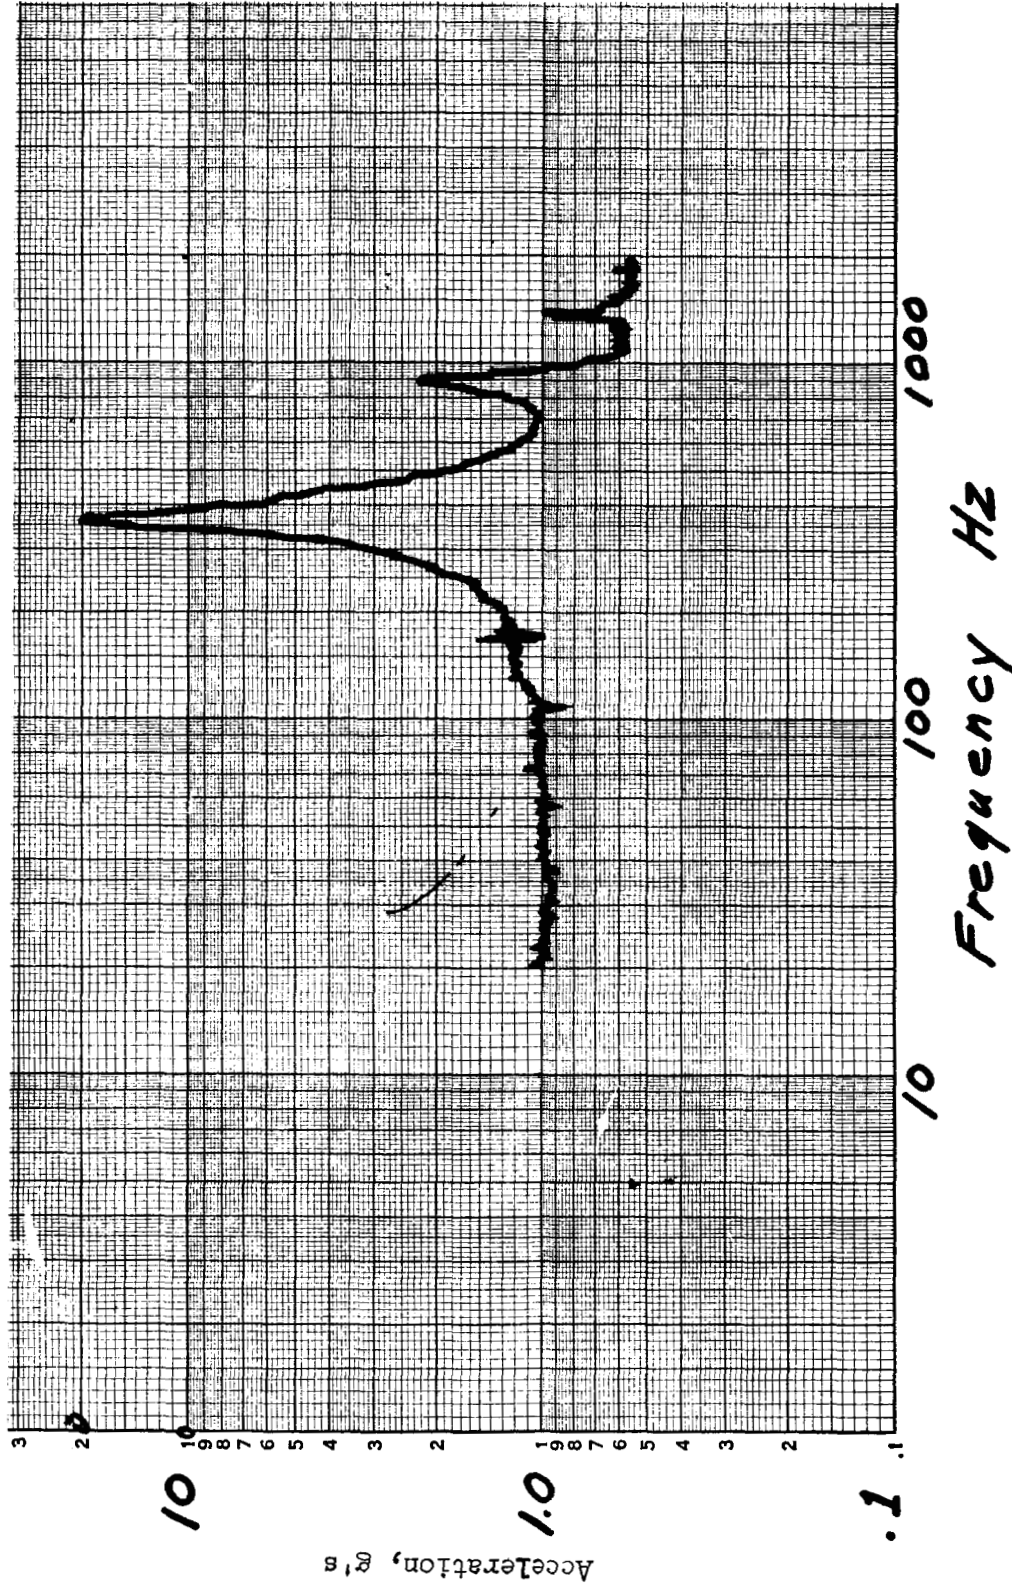
Figure 8. - Response of accelerometer 8 during 1G sweep at a rate of 1 octave/minute.

In the X axis, the 1-G sinusoidal tests showed most of the resonances at 350 to 360 Hz, with the highest amplification factor of 20 at the top of the motor housing (run 21). For the specified X-axis sweep, the resonances occurred from 250 to 300 Hz, the highest response being 110 G's at the discharge tube. In the Y-axis 1-G sweep (run 24), the resonances occurred at 360 Hz and 2000 Hz with amplification factors of 10 at the motor housing and 13 at the discharge tube, respectively. For the specification load-frequency sweep (run 25), maximums of 100 G's were noted at the pump volute and discharge tube at frequencies of 1600 and 1800, respectively.

A typical plot of "G" level versus frequency for an accelerometer on the motor housing is shown in figure 8.
